J. BURDINE BUILDING
200 E. Maple Street
Nicholasville
Jessamine County
Kentucky

HABS No. KY-228

ARCHITECTURAL DATA FORM

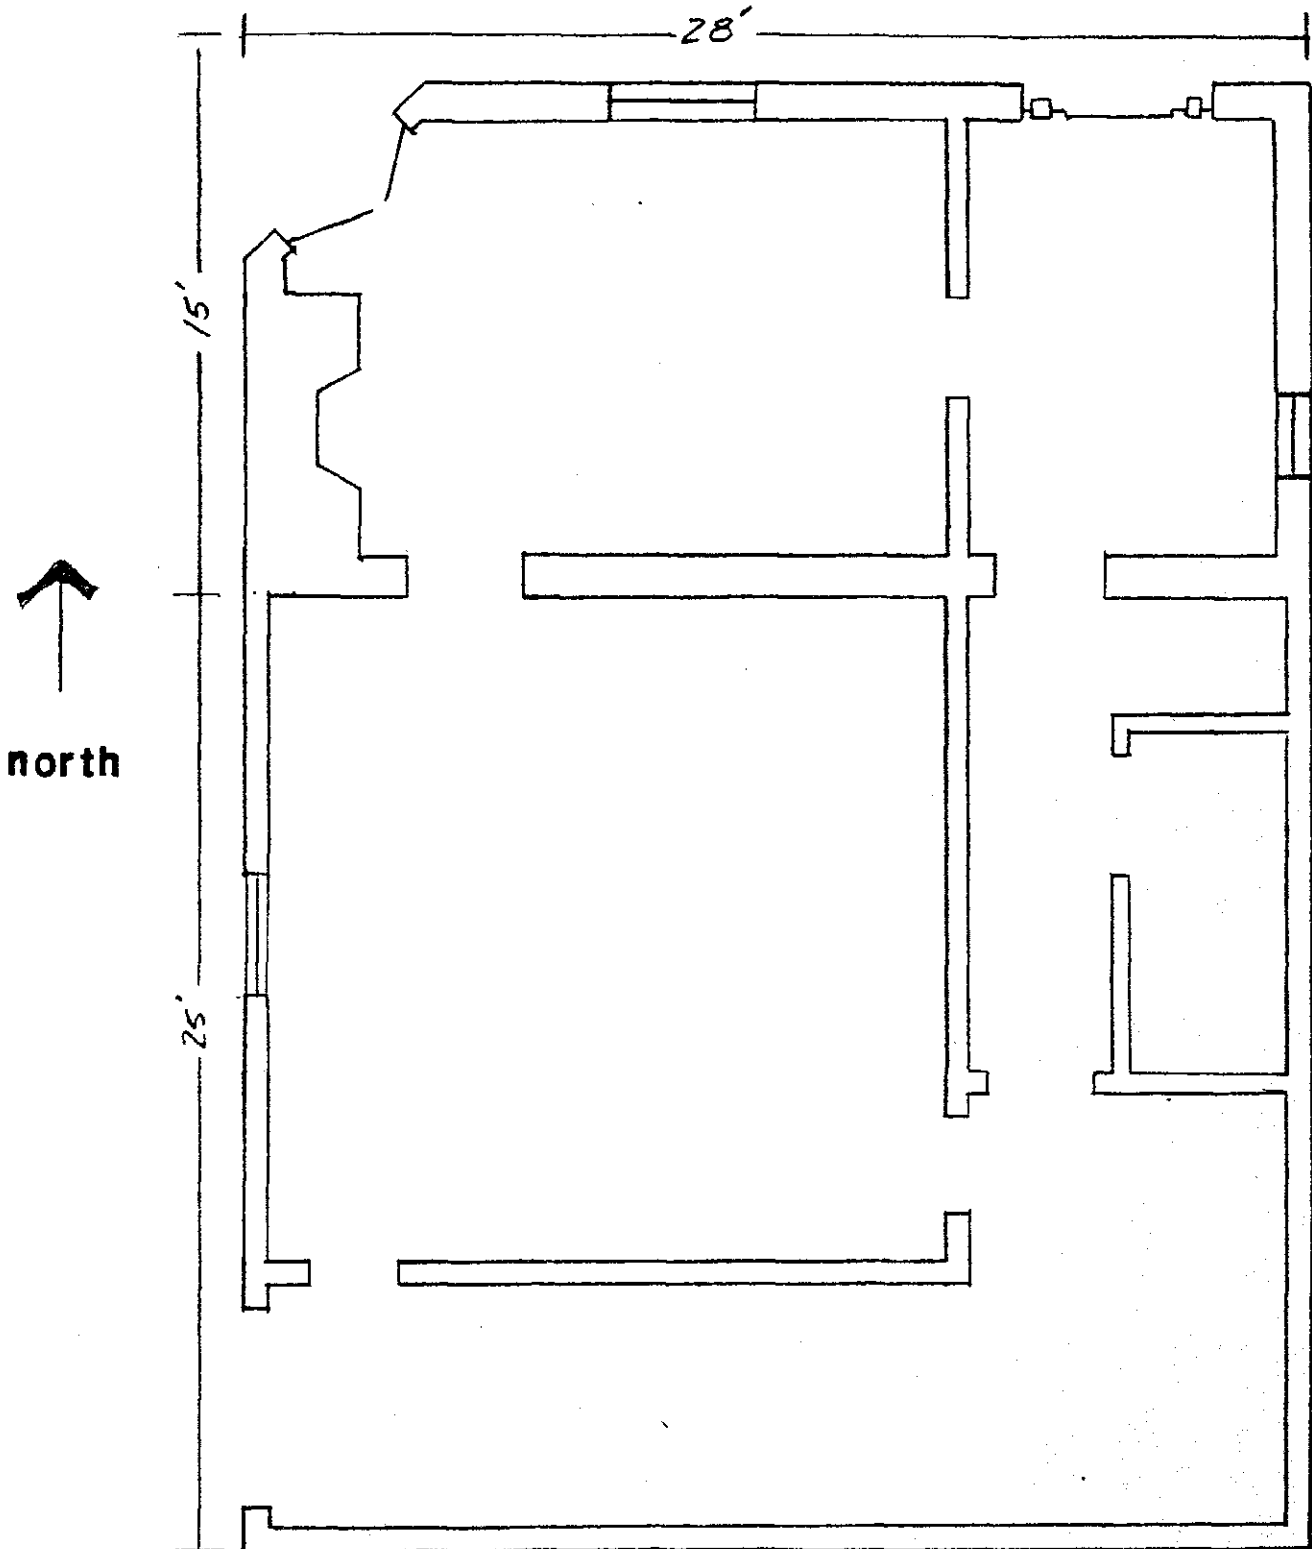
First Floor

SHAPE AND DIMENSIONS OF STRUCTURE (SKETCHED FLOOR PLANS ON SEPARATE PAGES ARE ACCEPTABLE) See attached sketch floor plans.		
EXTERIOR FEATURES OF NOTE Decorative Greek Revival frontispiece. Flemish bond at first floor and common bond at second floor of main facade. Common bond on rest of original walls. Radiating voussoir lintels at second floor of main facade. Gallery extends across west facade at second floor.		
INTERIOR FEATURES OF NOTE (DESCRIBE FLOOR PLANS, IF NOT SKETCHED) Surviving important detail includes one mantle at second floor, several paneled doors with decorative surrounds and plain baseboards. Interior has been altered throughout the years with original detailing removed. Recent vandalism has destroyed much.		
MAJOR ALTERATIONS AND ADDITIONS WITH DATES A large 25'x28' frame and clapboard addition has been built, at an unknown date, at the rear of the original house. A second floor gallery extends across the west side second floor. Metal door added in recent past at west side facade.
